Development Testing and Subsequent Failure Investigation of a Spring Strut Mechanism

Abstract

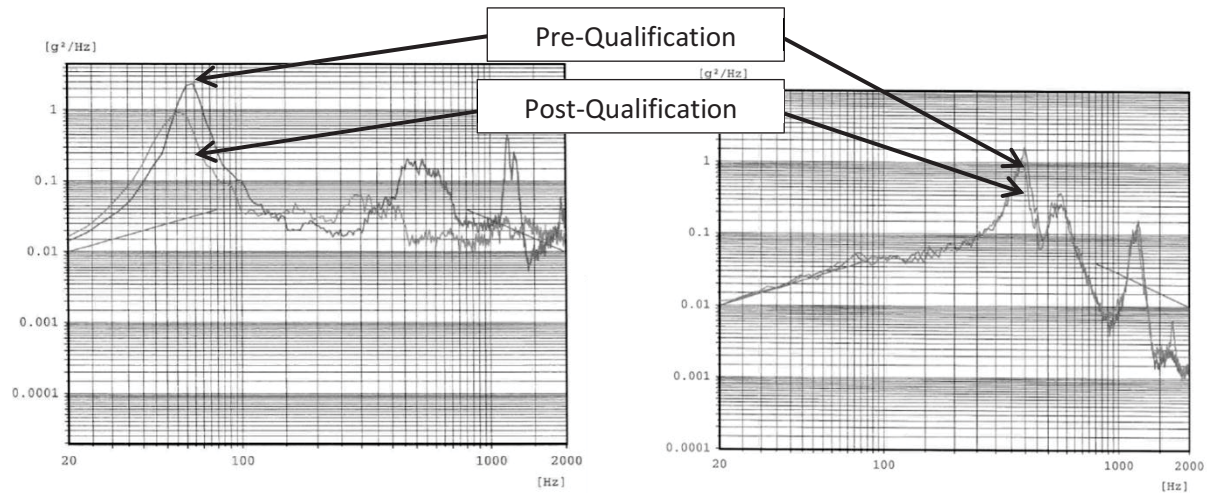
shows the minimal difference in the X-axis pre- and post-qualification level MWS runs. Additionally, the assessment team noted debris was observed exiting the spring strut when qualification levels were applied in both Z- and X-axes. A borescope was used after testing in each axis to qualitatively assess the magnitude of internal wear and provide a comparison from axis to axis. For the Z- and X-axis testing the hardware was exposed to the target levels with no significant (i.e., operation-inhibiting) damage observed and thus, deemed successful.

Figure 5. Typical Pre- and Post-Qualification MWS Differences (Z-axis [left]; X-axis [right])

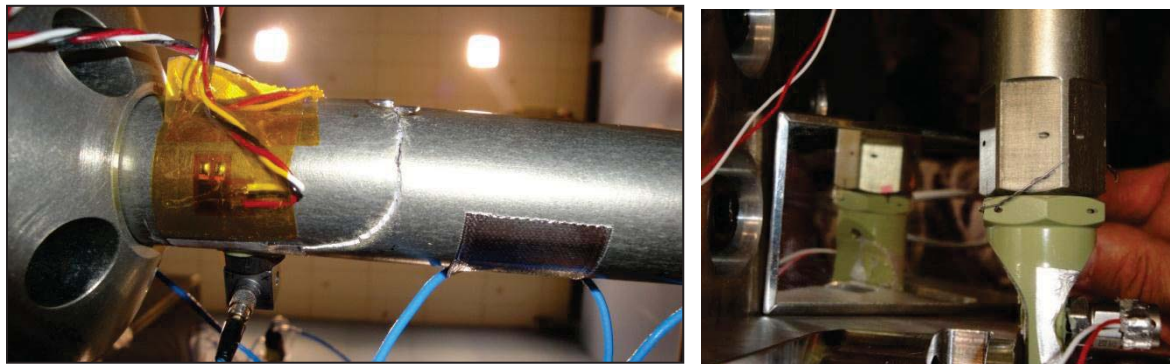
The Y-axis was anticipated to be the worst environment for the hardware. MWS and acceptance levels were completed in the Y-axis. However, during the qualification level test, a distinct change in the sound and response produced by the hardware was observed 27 seconds into the full level qualification run. A lack of clear visual failure indicators coupled with ill-defined criteria for test stoppage resulted in continuation of the testing to the full duration (3 minutes). Upon completion of the test, the NESC team found the secondary piston had failed at the aft tooling hole and the lockwire restraining the forward lug from rotating had failed (Figure 6). Due to the failure of the spring strut hardware, no further random vibration testing could be completed and the hardware was taken back for investigation and performance testing. Note that even though the test hardware incurred a failure, the testing was ultimately considered successful because it flagged design deficiencies before they were encountered late in the test and verification cycle.

Figure 6. Structural Failure of Secondary Piston at Aft Tooling Hole [left]; Lockwire Failure at Forward Lug [right]

Prior stress and fracture analyses did not include the tooling holes, and the secondary piston was not considered fracture critical. Large structural margins in this analysis deemed the secondary piston satisfied the definition of a 'low risk' component and were subsequently classified as non-fracture critical. These prior analyses were based on flight load factors found to be inadequate and inconsistent with the EFT-1 flight configuration. After the secondary piston failure, an updated fatigue analysis was performed accounting for the off-nominal secondary piston rotation to quantify the Cumulative Damage Index (CDI) using Rayleigh's distribution and Miner's Rule for response to the base input Power Spectral Density (PSD). In summary, the analysis results showed exceedance of the secondary piston fatigue life capability at the tooling hole ($CDI = 1.519 > 1.0$) when subjected to Y-axis qualification levels in a maximum bending condition. After the failure, the spring strut was evaluated by LM and Marshall Space Flight Center (MSFC) failure analysis groups with both groups concluding the structural failure occurred at the aft-most secondary piston tooling hole initiated in fatigue followed by ductile overload. The opposite side of the failed tooling hole also showed the beginnings of fatigue cracking.

Due to the rotation, strut tooling holes, nominally in the neutral bending axis during the Y-axis vibration test, were placed in maximum bending. Once the fatigue life capability at the tooling hole was exceeded, the secondary piston failed by crack growth and overload.

The NESC team was kept apprised of the redesign activities by the MPCV CM subsystem management team. LM made design changes intended to prevent loosening of the threaded parts and eliminate fatigue initiation sites, then retested the strut. These changes included an increase in the size of the secondary locking patches, quantity and diameter of lockwire, and preload at the end fitting joints (50 percent of F_{ty}). Additionally, the tooling holes were removed and a new retention tool design was devised. Once the initial redesign effort was complete, LM began with the Y-axis test, which was the worst case and the axis in which the secondary piston failed. Shortly after reaching qualification levels, the strut suffered another failure. This time, the forward lug fractured at the secondary piston interface. A subsequent investigation by LM determined fatigue failure was the cause and that the corrections made appeared to be working up

LM performed a residual life assessment on all parts to identify any other components at risk. Those items with insufficient life were replaced. Numerous design changes as shown in Figure 12 were also incorporated: the secondary piston was redesigned to eliminate the joint between the rod end and the secondary piston by replacing the assembly with a rod end integral to the secondary piston, the tooling hole interface to the retention tool was replaced with a clamp-style tool., and the aft cap-to-actuator housing interface was adhesively bonded after application of the required preload. The new design was placed through a new random vibration test, this time using an approach that included qualification for AVT per reference 5, and the unit passed the vibration test and post-vibration performance testing.

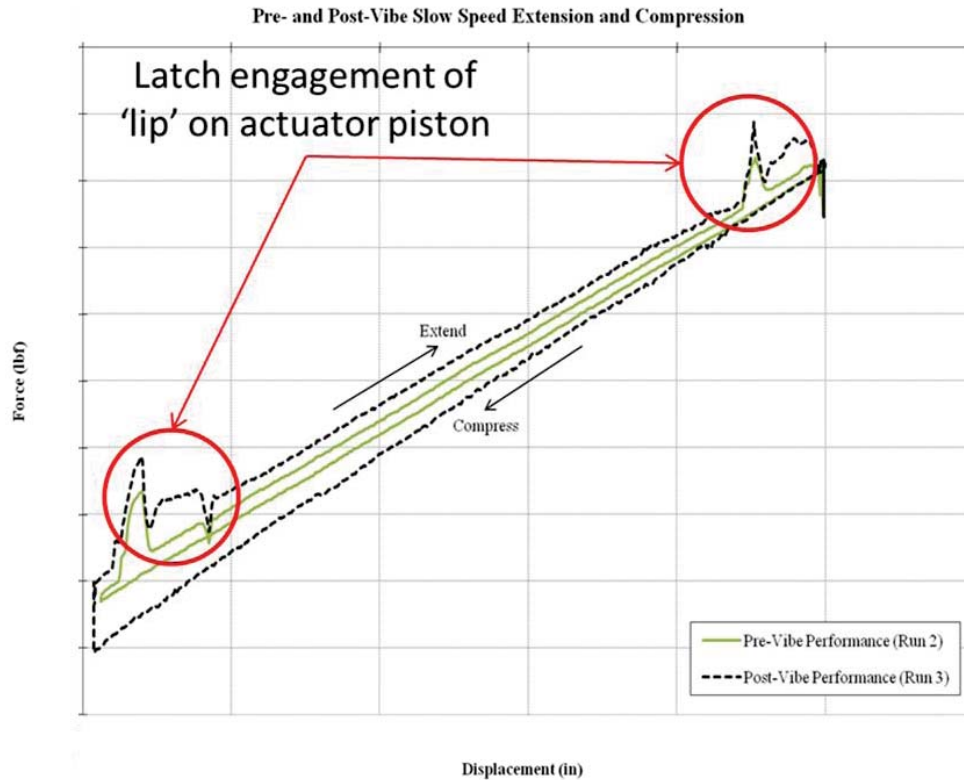
After failure during the random vibration testing, the strut was returned to the performance testing facility with a truncated secondary piston to remove the failed portion of the strut. Using a cupping interface, post-vibe performance deployment tests were performed with the strut assembled in the load frame. The post-vibration performance test served primarily to assess whether there were any large excursions from the nominal force-deflection curve. These excursions could be indicative of significant damage to the spring strut sliding surface. The post-vibration performance test satisfied the nominal expected end of travel force of $165 \text{ N} \pm 27 \text{ N}$ ($37 \pm 6 \text{ lb}_f$) and resulted in nominal engagement of the anti-back travel latches. Force versus displacement within the expected tolerance yielded acceptable force margin based on the next high assembly assumptions and calculations. A comparison of the pre- and post-random vibration performance test is shown in Figures 8.

Figure 8. Force versus Displacement Plot for Slow Speed Extension

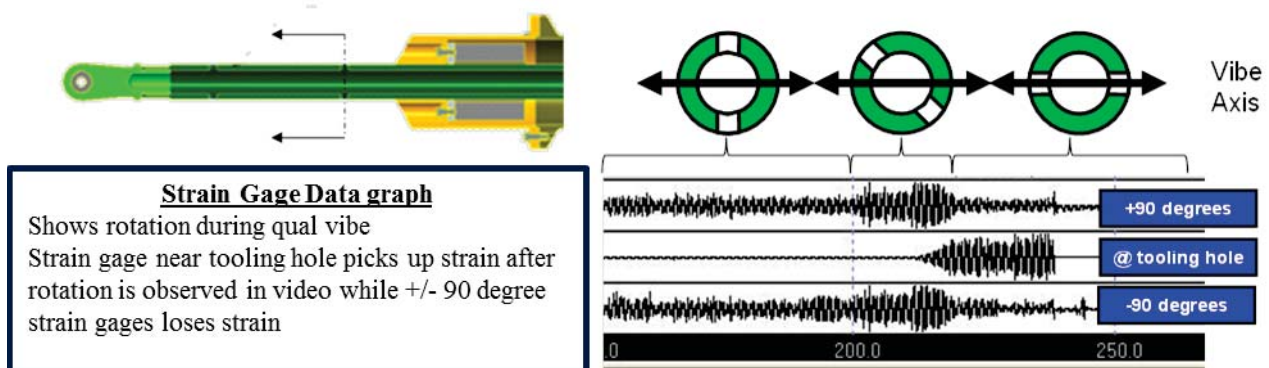
1. **Test Video and Strain Gauge Data:** Immediately after application of the qualification levels, the SM side assembly (aft cap, actuator housing, and forward cap) rotated clockwise (looking SM to umbilical side). Lagging this rotation, the secondary piston was observed to rotate counterclockwise. Inspection of data from strain gauges mounted on the secondary piston and visual indicators of mounted accelerometers indicated a rotation of approximately 90 degrees. Strain gauge data with indicators of tooling hole orientation relative to the Y-axis applied load can be found in Figure 10. Approximately 27 seconds after application of qualification levels (242 seconds) there was a noticeable decrease in noise and strut dynamic response. No noticeable damage was observed, so the test was continued to the full duration at 395 seconds.

Figure 10. Strain Gauge Data and Strut Rotation

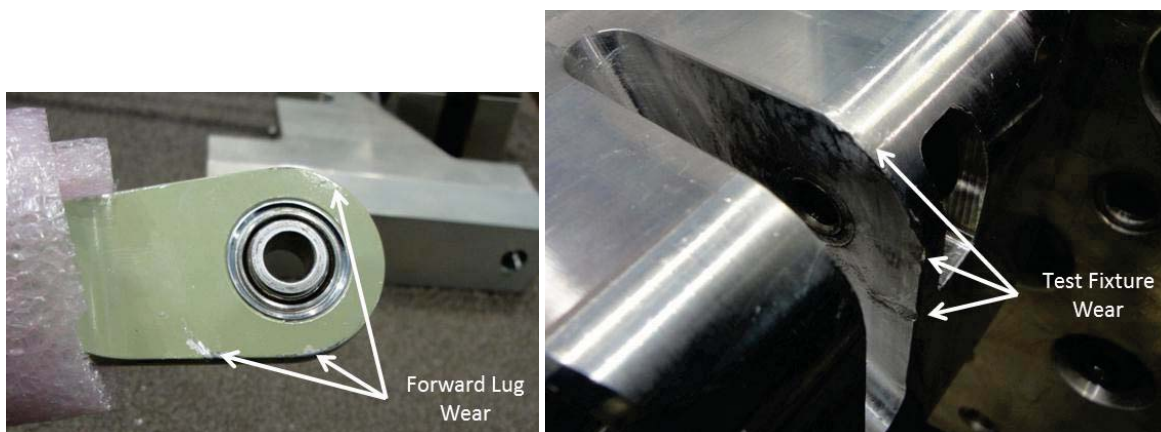
7. **End Fitting Rotational Offset:** Indications of wear are evident on the end fittings and adjoining clevises (Figure 11). Contact due to misalignment/rotational offset would have imparted a force off-axis from the strut and induced a torque applied to the end fittings. If the force was sufficient to overcome resistive elements of the joint, then the end fittings could have tightened or loosened. Loosening at the forward strut interface would have permitted an applied torque to more easily rotate the secondary piston relative to the forward lug.

Figure 11. Wear Post-Vibration Testing (Forward Lug [left]; Test Fixture [right])

During vibration testing there was contact between the aft cap and SM side actuator bracket and the forward lug and test fixture, with significant wear observed during post-test inspection. This produced a constraint and source of induced reaction force off-axis from the strut. The strut design also permitted a CG offset due to a combination of sliding contact interfaces, machining tolerances, non-axisymmetric nature of select piece parts, elastically buckled spring, and gravity loads as installed in the random vibration test fixture. The design also did not include an alignment feature integral to the strut, therefore forward lug and aft cap strut end fitting alignment was not guaranteed and permitted rotational misalignment between the two rod ends.

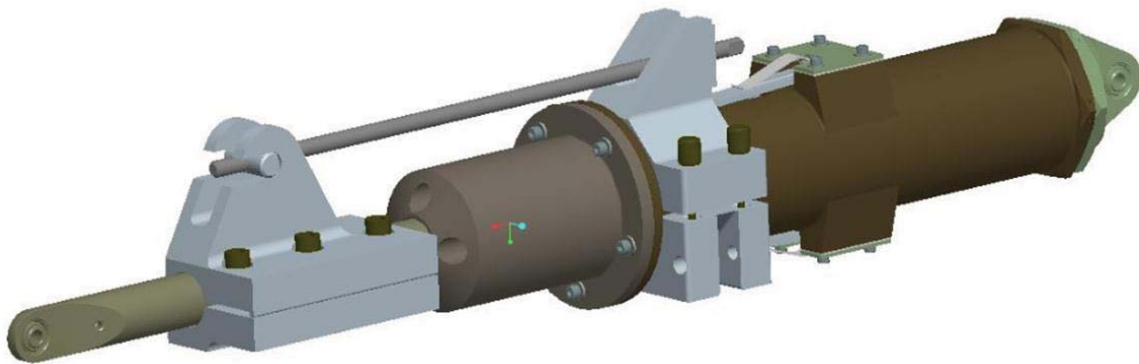
Figure 12. Updated Spring Strut Design
